DEPARTMENT OF TRANSPORTATION

Quality Assurance and Source Inspection

Contract #: 04-0120F4Cty: SF/ALA Rte: 80 PM: 13.2/13.9File #: 1.28**WELDING INSPECTION REPORT****Resident Engineer:**Siegenthaler, Peter**Address:** 333 Burma Road**City:** Oakland, CA 94607**Report No:** WIR-026050**Date Inspected:** 04-Aug-2011**Project Name:** SAS Superstructure**OSM Arrival Time:** 700**Prime Contractor:** American Bridge/Fluor Enterprises, a JV**OSM Departure Time:** 1730**Contractor:** American Bridge/Fluor Enterprises, a JV**Location:** Job Site**CWI Name:** See Below**CWI Present:** Yes No**Inspected CWI report:** Yes No N/A**Rod Oven in Use:** Yes No N/A**Electrode to specification:** Yes No N/A**Weld Procedures Followed:** Yes No N/A**Qualified Welders:** Yes No N/A**Verified Joint Fit-up:** Yes No N/A**Approved Drawings:** Yes No N/A**Approved WPS:** Yes No N/A**Delayed / Cancelled:** Yes No N/A**Bridge No:** 34-0006**Component:** Orthotropic Box Girder & Tower**Summary of Items Observed:**

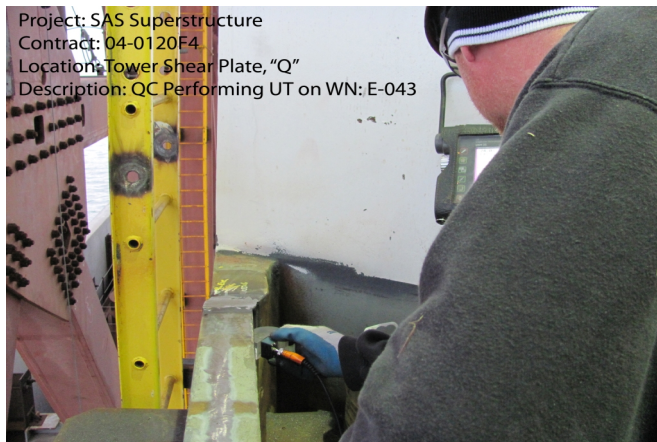
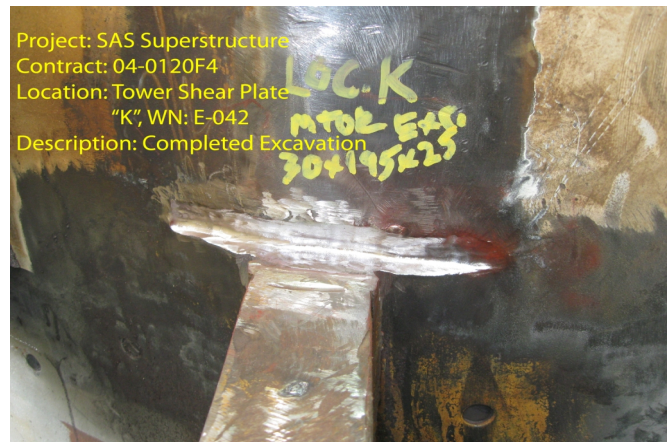
The digital photographs below illustrate some of the work observed during this scheduled work date.
